# Flight Safety

*Published for the pilots of American Airlines*

NOV. / DEC. 1999

# Flight 1420

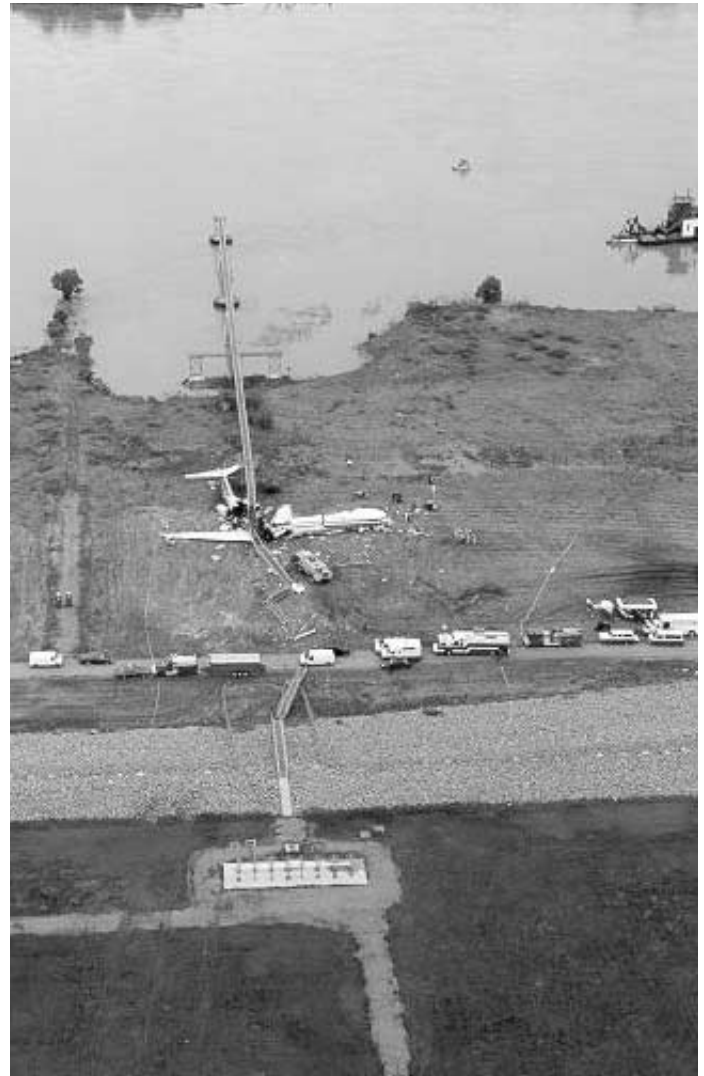
**O**n June 1, 1999, American Airlines Flight 1420 overran the runway and impacted the approach lighting system during landing in Little Rock, Arkansas. The accident involved a McDonnell Douglas MD-82 originating from Dallas-Fort Worth. The aircraft carried 6 crew and 139 passengers. One hundred thirty-four people survived the accident including a two-year-old in a child-restraint system.

Little Rock accident site

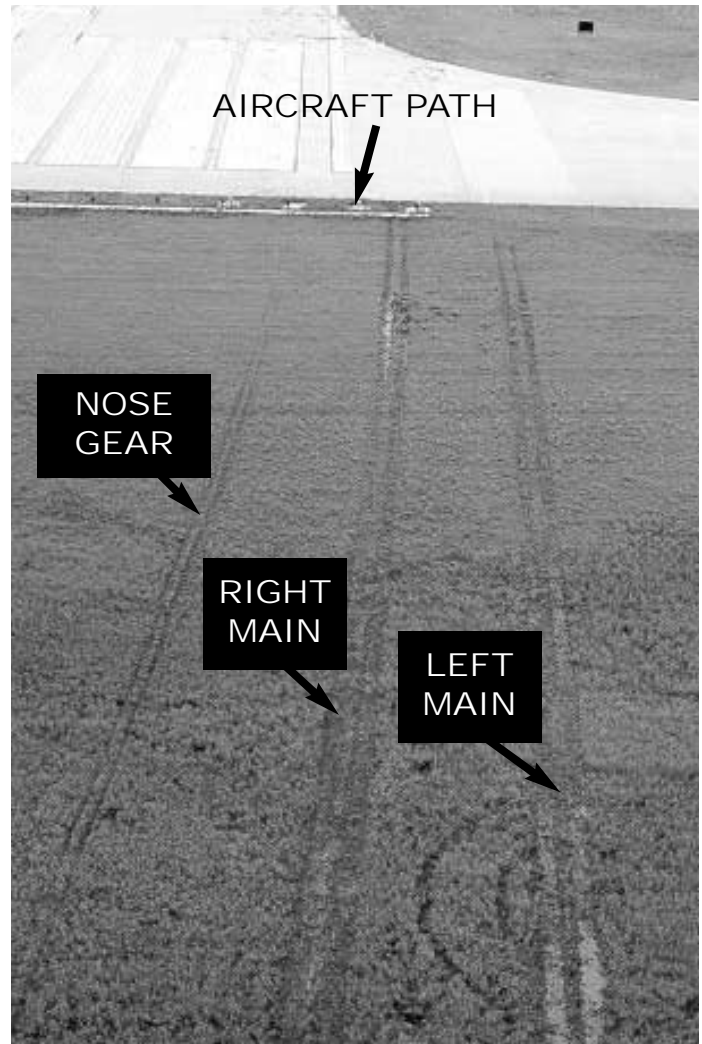
**Tracks showing aircraft in a nose right skid departing runway's left side**

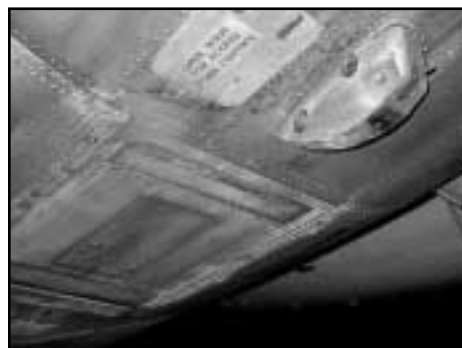
Tailstrikes that occur during landing usually cause more damage than those incurred on takeoff. The most damaging incidents occur when the aircraft's tail makes contact with the runway before the landing gear. This causes the tail to absorb large amounts of energy and often damages the rear pressure bulkhead.

MD80 tailskid damage

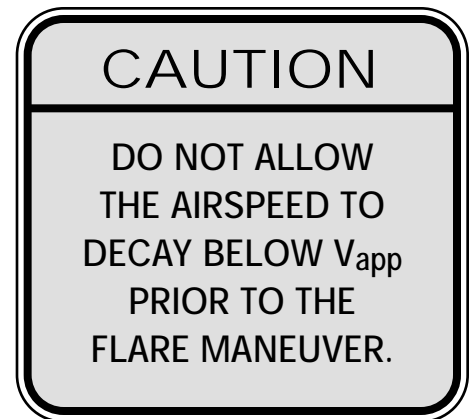
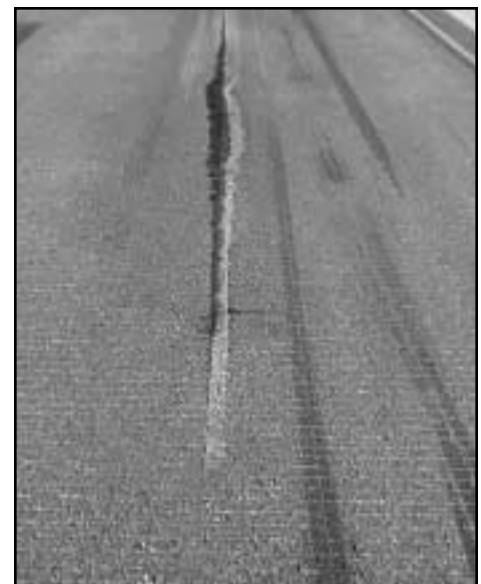
Tailskid strike in runway

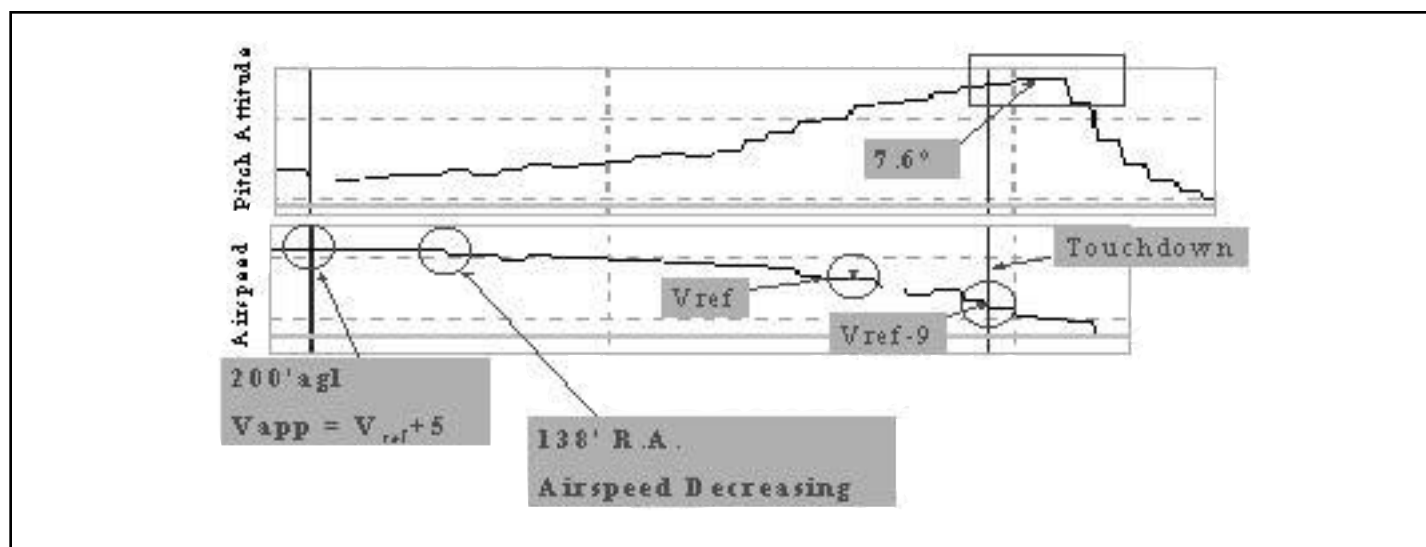
The aircraft lost 18 knots in velocity during the final 200 feet until the aircraft actually touched down. This 18 knot loss in velocity through 200 feet occurred in 25 seconds and resulted in a **53,000,000 foot pound** loss in kinetic energy. The engines would have to produce **over 9,000 pounds of additional thrust** during this descent to return to the target speed —  $V_{app}$  — needed for the land-

Flight-data-recorder trace

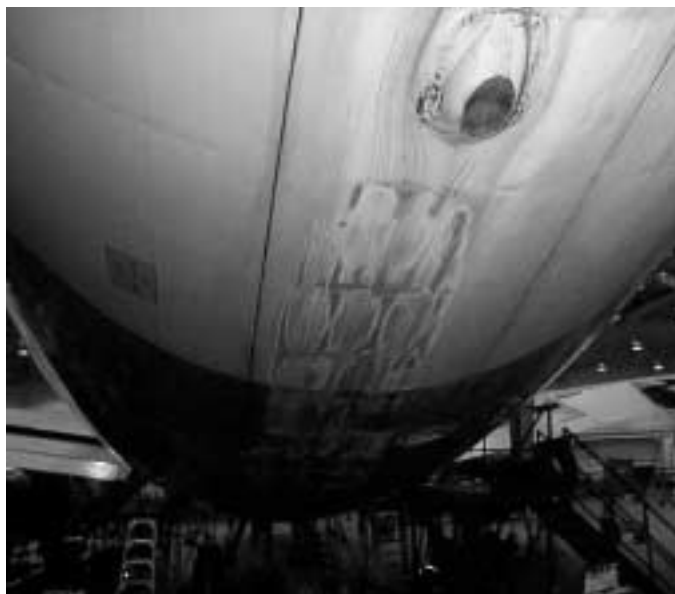
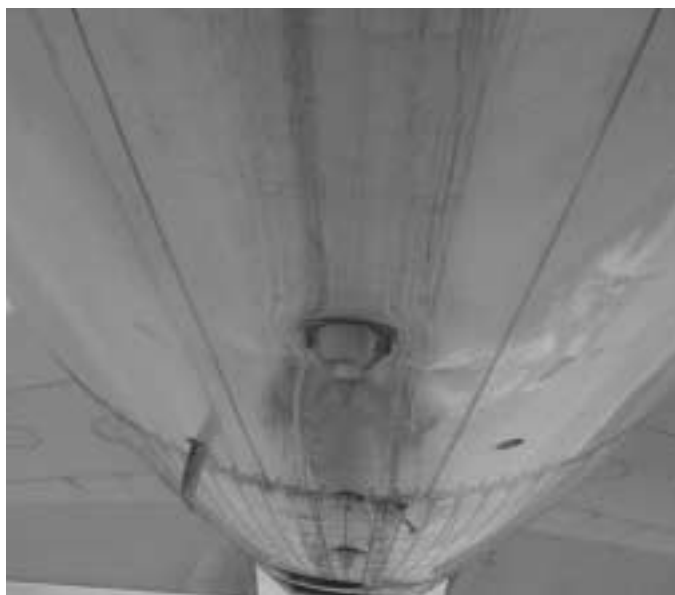
**T**he A300 fleet has suffered three major tailstrikes since 1997, two of these resulted in sufficient damage to the aircraft to be classified as accidents by the NTSB. Each airplane was Out-Of-Service (OTS) for approximately 4-6 weeks and incurred about 3-5 million dollars worth of damage to each airframe; this did not include loss of service time. In an effort to increase tailstrike awareness and to prevent them from recurring, we will look at the common causal factors between these events and what actions can be done to prevent them. Although this may seem like a problem for only the A300 pilots, the principles reviewed will apply to all the fleets. Synopses of each event were taken from NTSB reports and not company documents.

A300 tailstrike damage
