# Flight Safety

*Published for the pilots of American Airlines*

NOV. / DEC. 1999

# Flight 1420

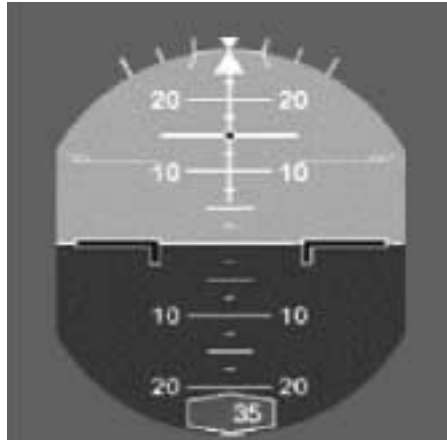
The pitch attitude given by the flight director might lag behind an aggressive rotation for takeoff or go-around, risking a tailstrike, especially if there is insufficient thrust.

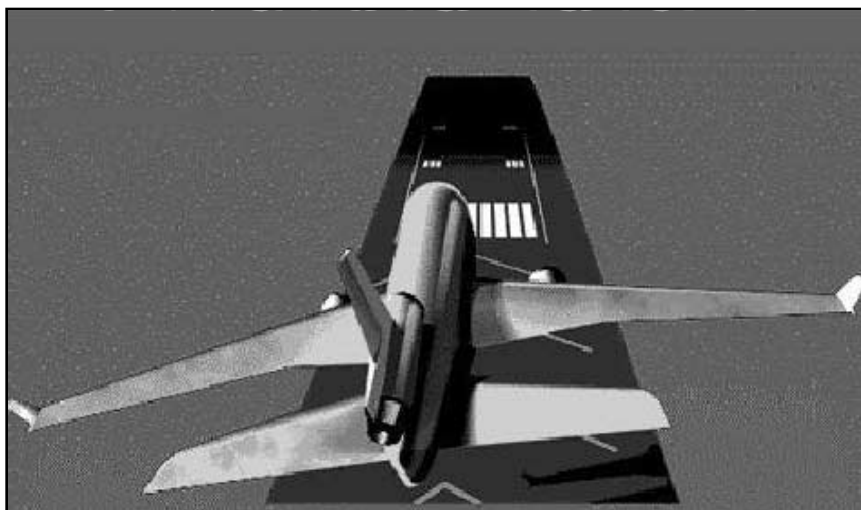
An inability to remain on the glide slope is a cause of tailstrike.

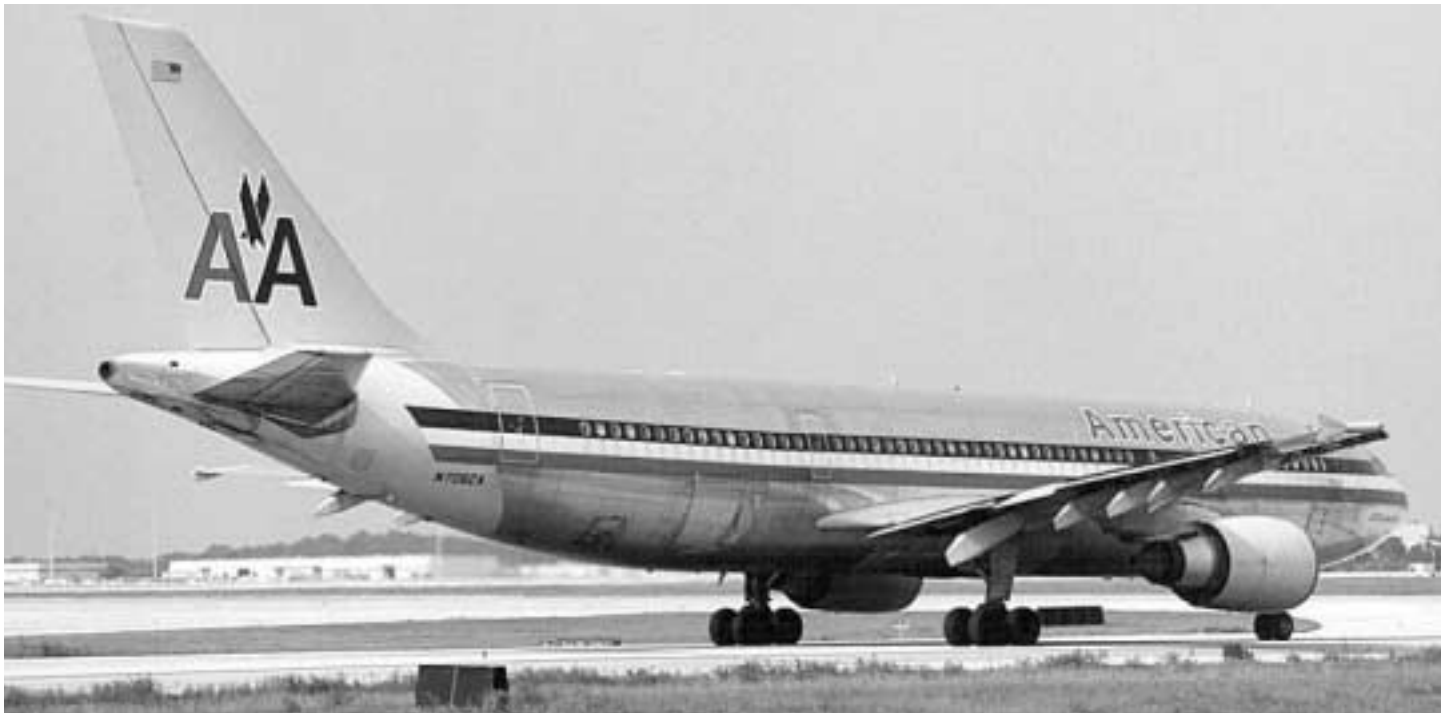
Each airplane was Out-Of-Service for approximately 4-6 weeks and incurred about 3-5 million dollars worth of damage to each airframe.

A300 tailstrike damage
