Flight Safety

Published for the pilots of American Airlines

First Quarter 2000

Looking Forward	1
Decision-Making	2
NTSB Public Hearing – Flight 1420	4
Contaminated Runways	5
Hard Landings	8
ASAP Turns Five and a Half	11

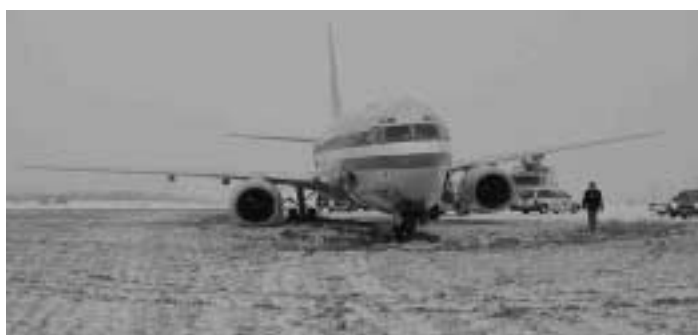
737-800 Runway Overrun, ORD

It is interesting to note that the **least effective** braking is at the end of the runways because of rubber deposits and snow or ice accumulation. Often the rollout end of a runway is worse than the rest of the runway because neither landings nor takeoffs traverse this region so the contami-

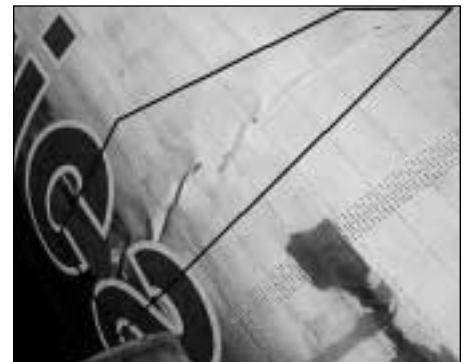
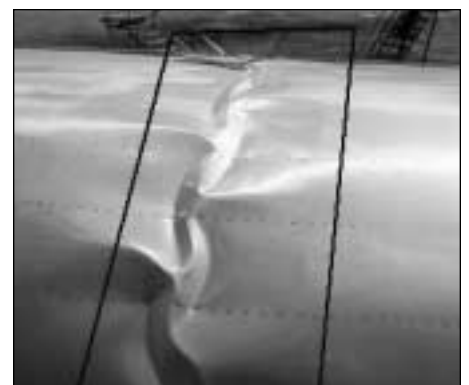
Aircraft damage from the Sao Paulo hard landing, 1992

The first accident (NTSB DCA93WA004) occurred while landing in Sao Paulo, Brazil on runway 09L and it involved a B-767-300. The landing was during daylight in VMC, winds 340/09; the runway was dry with the First Officer flying. Autospoilers (prior to change in mandatory landing procedure) and auto-brakes were not used. The approach was described as normal, with autopilot disconnect occurring at 2000 feet. From 500 feet AGL, the final approach phase was conducted with all appropriate radio callouts. At 300 feet the Captain called out a 17 knot crosswind as displayed on the FMC and a minus bug of 4-5 knots. The First Officer acknowledged, disconnected the autothrottles and added power. The approach was flown with a 10-degree crab into the wind. At 100 feet the windsock indicated a crosswind of 10 knots. At approximately 30 feet, the aircraft was aligned with the runway centerline. At 10 feet, power was

reduced to idle. Main gear touchdown was normal, with the left main gear touching down first. The aircraft then had a light skip and settled back down on the main gear. After main gear touchdown the First Officer lowered the nose gear onto the runway. Once he felt runway contact on the nose gear, forward pressure was increased to ensure nose wheel contact with the runway because of the crosswind condition. Nose gear contact with the runway was reported as firm. Upon exiting the aircraft, maintenance personnel advised the crew of damage to the upper fuselage. The fuselage crown skin was buckled from station 610 to 632 and from stringer 14 left to 14 right. The Brazilian authorities investigated the accident with assistance from the NTSB.

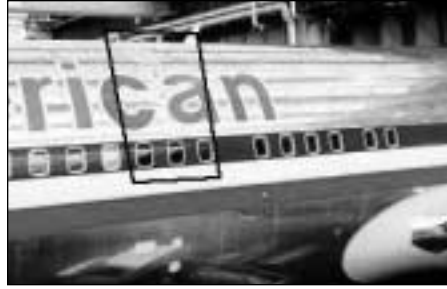
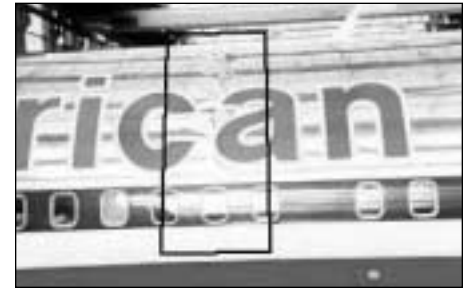
Aircraft damage from London Heathrow hard landing, 1999

the aircraft touched down on the main gear at an airspeed of 146 knots and with a positive pitch attitude of 4°. The aircraft subsequently bounced three times, resulting in four touch-downs over a total period of 6 seconds; during this time both thrust levers remained at idle. Additionally, over the same period, roll attitude varied between 3° left and 1° right.

At the conclusion of the investigation, the AAIB stated that the accident sequence started when the aircraft bounced on the first touchdown and the DFDR, CVR, and flight crew information indicate that the damage to the aircraft resulted from a subsequent Pilot Induced Oscillation (PIO). This PIO was initiated as the aircraft bounced on the first touchdown and the damage probably occurred on the final touchdown. The extent of the

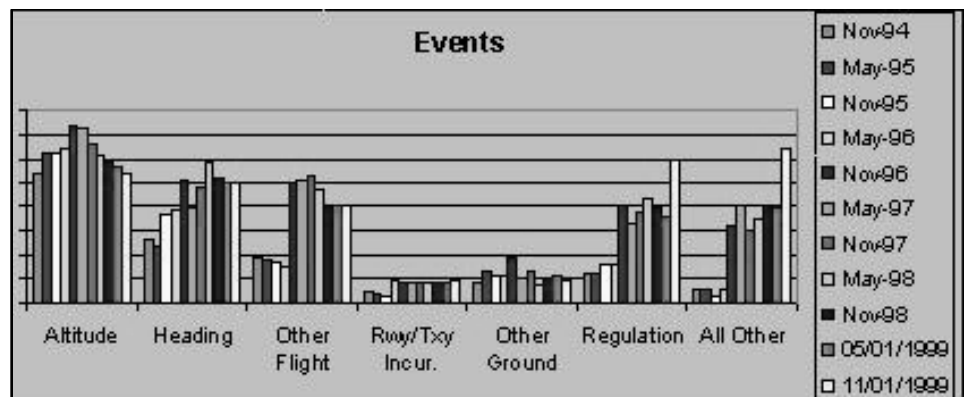
rate. The increase was associated with decommissioning of the Omega Navigation System (ONS) and its delayed replacement with GFMS on MD-80s. Heading deviations on these aircraft rose sharply as the decommissioning began. The decline from the peak rate may be attributed to pilots on these aircraft re-establishing habit patterns for enroute navigation by ground based facilities or to increasing numbers of aircraft having GFMS installed, but overall, heading deviations remain significantly more frequent than 3 years ago.

Altitude deviations are continuing a 3-year decline. Heading deviations, which had shown a long-term increase through early 1998 and leveled off over the past year, were up slightly, but well below their peak

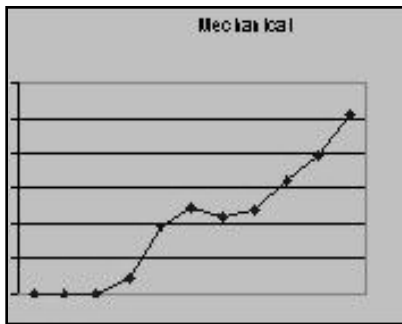
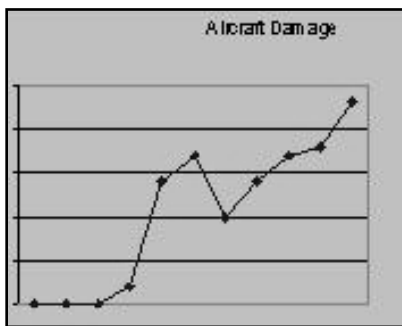
Deviations fitting “all other” categories have increased over the life of the program. This represents a wide range of category codes most frequently including aircraft damage, mechanical failure, hazardous materials, and turbulence encounters. The charts below review two of these categories from 1994 through 1999 – mechanical problems and aircraft damage. The number of ASAP reports in both of these areas are on the rise, and we will discuss each in more detail below.

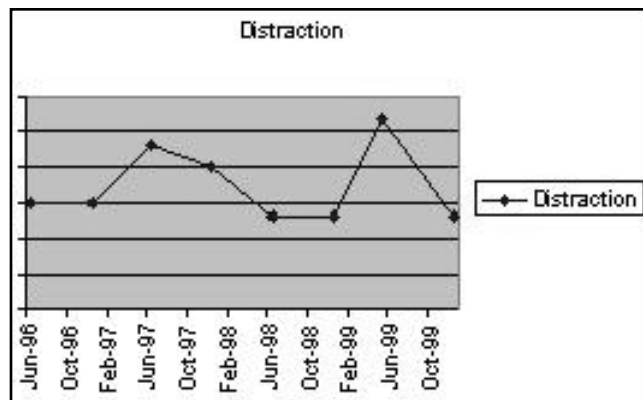
- Distraction from primary duties to other tasks (13% of randomly sampled reports).** Distractions at a critical point in flight have produced altitude deviations, navigation errors, and runway incursions. The word “distraction” usually implies that attention is drawn from critical tasks to irrelevant factors in the situation. That is rarely the case in these reports. While distractions include factors within the pilots’ control such as timing of cabin communications and PA’s, most are inherent in the operation, such as weather, ACARS messages, distractions related to autoflight systems, and minor mechanical problems. Most of these events have occurred at a point of flight where more than one duty must be accomplished – pilots must set priorities between primary and secondary tasks. While this remains the most frequent contributing factor, these reports were down sharply over the last report – reversing a serious concern – and returning to the levels of a year ago. This may reflect the results of recent emphasis in training and publications, may be a temporary correction, or may reflect other historical factors. Specifically, a review of the trend in distractions over the past four years reveals a disturbing pattern

of events associated with distractions and periods of peaking labor-management unrest. During the six months surrounding the pilot strike in 1997, and the following six months in which the resolution played out, events associated with distractions were sharply higher. In the six months surrounding the dispute over the Reno Air integration, events associated with distractions were at their highest point in the program. This suggests how labor-management unrest may lead to safety-related issues, but the effects are indirect. Note that the acts or interruptions that distracted pilots from key tasks were factors always present in the operation, such as conflicting duties and priorities, but appear to be consequential more often during unrest. From this perspective, our labor-management struggles seem to reduce the capacity of our pilots to set priorities and deal with distracting events, rather than to be distracting in and of themselves. This is a double-edged sword. To the good, we have little evidence from our reports that contractual issues are under discussion during critical phases of flight. To the bad, this reduced capacity is unlikely to be apparent to pilots as they do their jobs. All pilots must take great pains to set priorities and control those distractions that they can. Management and APA’s continued cooperation and dialog will produce positive safety results.

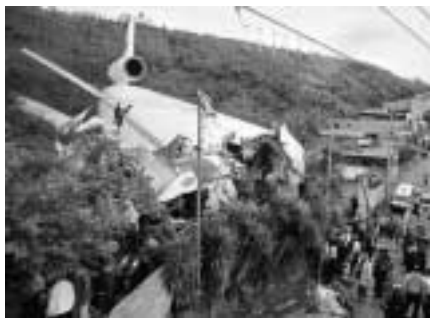
Landing Accident DC-10

While landing on runway 19, a DC-10 with 314 occupants (18 crew, 296 pass.) overran the runway end and slid off the airport property down an embankment at La Aurora Airport in Guatemala City. The aircraft went down a steep slope and crashed into 10 houses before coming to a stop. The accident caused 26 fatalities of which 2 were crew, 15 were passengers, and 9 were persons on the ground. Preliminary information indicates that the runway was wet and that the aircraft either slid off the runway or landed long and was unable to stop. Guatemalan authorities with assistance from the NTSB are still investigating the accident.

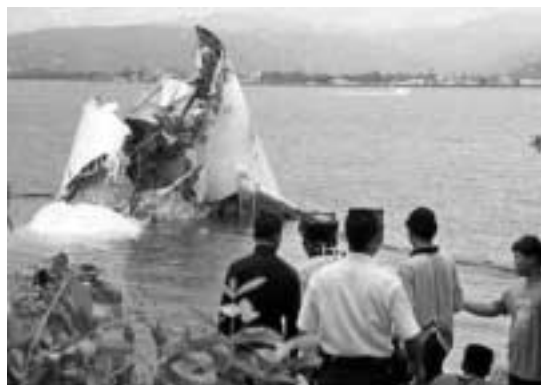
Landing Accident MD-11

Following a manually flown VOR/DME approach to Runway 07 at Subic Bay, the MD-11 touched down, reportedly landing long and fast. The aircraft was not stopped before the end of the runway consequently overrunning the end and hitting a concrete post and slamming into a wire fence before plunging into the bay. The aircraft broke up and sank. The accident happened in darkness. Weather, reportedly, wind, calm, visibility 6km in intermittent light rain and cloud, scattered at 1,800 feet and broken at 7,000 feet. The runway was wet. The aircraft was operating a cargo flight. Both crewmembers were injured in the accident.

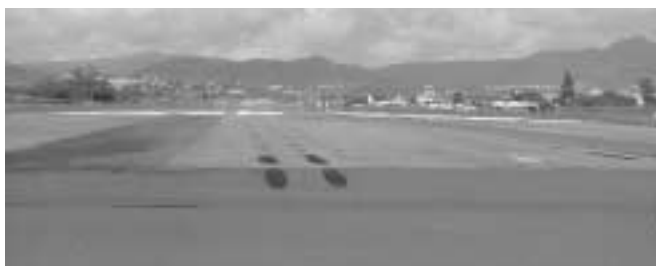
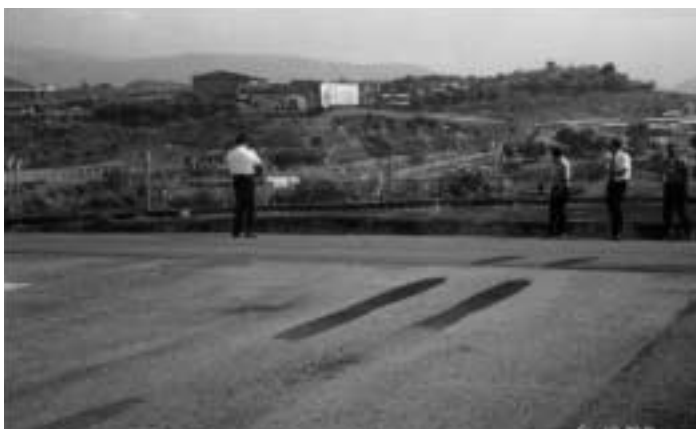
June 14, 1999, Incident– B-757 Landed Short

A Boeing 757 struck the airport boundary fence at Tegucigalpa, Honduras while landing on runway 19. There were no injuries and minor damage to the airplane.

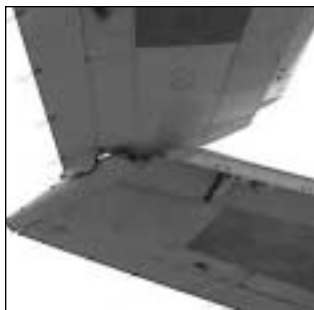
June 29, 1999, Incident – Boeing 767-300 vs. Boeing 767-200

A Boeing 767-300 on a scheduled flight to Stockholm, Sweden collided on the ground with an American Airlines B-767-200, which was stopped on the International Ramp at the O’Hare International Airport, Chicago, Illinois. There were no injuries to the 3 cockpit crew, 10 cabin crew, and 173 passengers on board the 767-300.

In addition, there were no injuries to the two mechanics on board 767-200. The 767-300 received minor damage to its right wingtip. The 767-200 was at gate M-3 at the International Terminal and was pushed back onto the ramp so that it could be repositioned to the domestic side of the airport. The 767-300 had been parked at gate K-19 and was given clearance to taxi to Runway 32R via the Bravo Taxiway. The right wing of the 767-300 contacted the left wing of the 767-200 as it was taxiing on the Bravo Taxiway. This event resulted in a change of AA procedures when pushing back from M3. The current procedure is push directly onto Bravo.
